ANALYTICAL RESULTS REPORT for FOCUSED SITE INSPECTION

RICO-ARGENTINE
Rico, Dolores County, Colorado

TDD No. 0308-0013

FEBRUARY 9, 2004

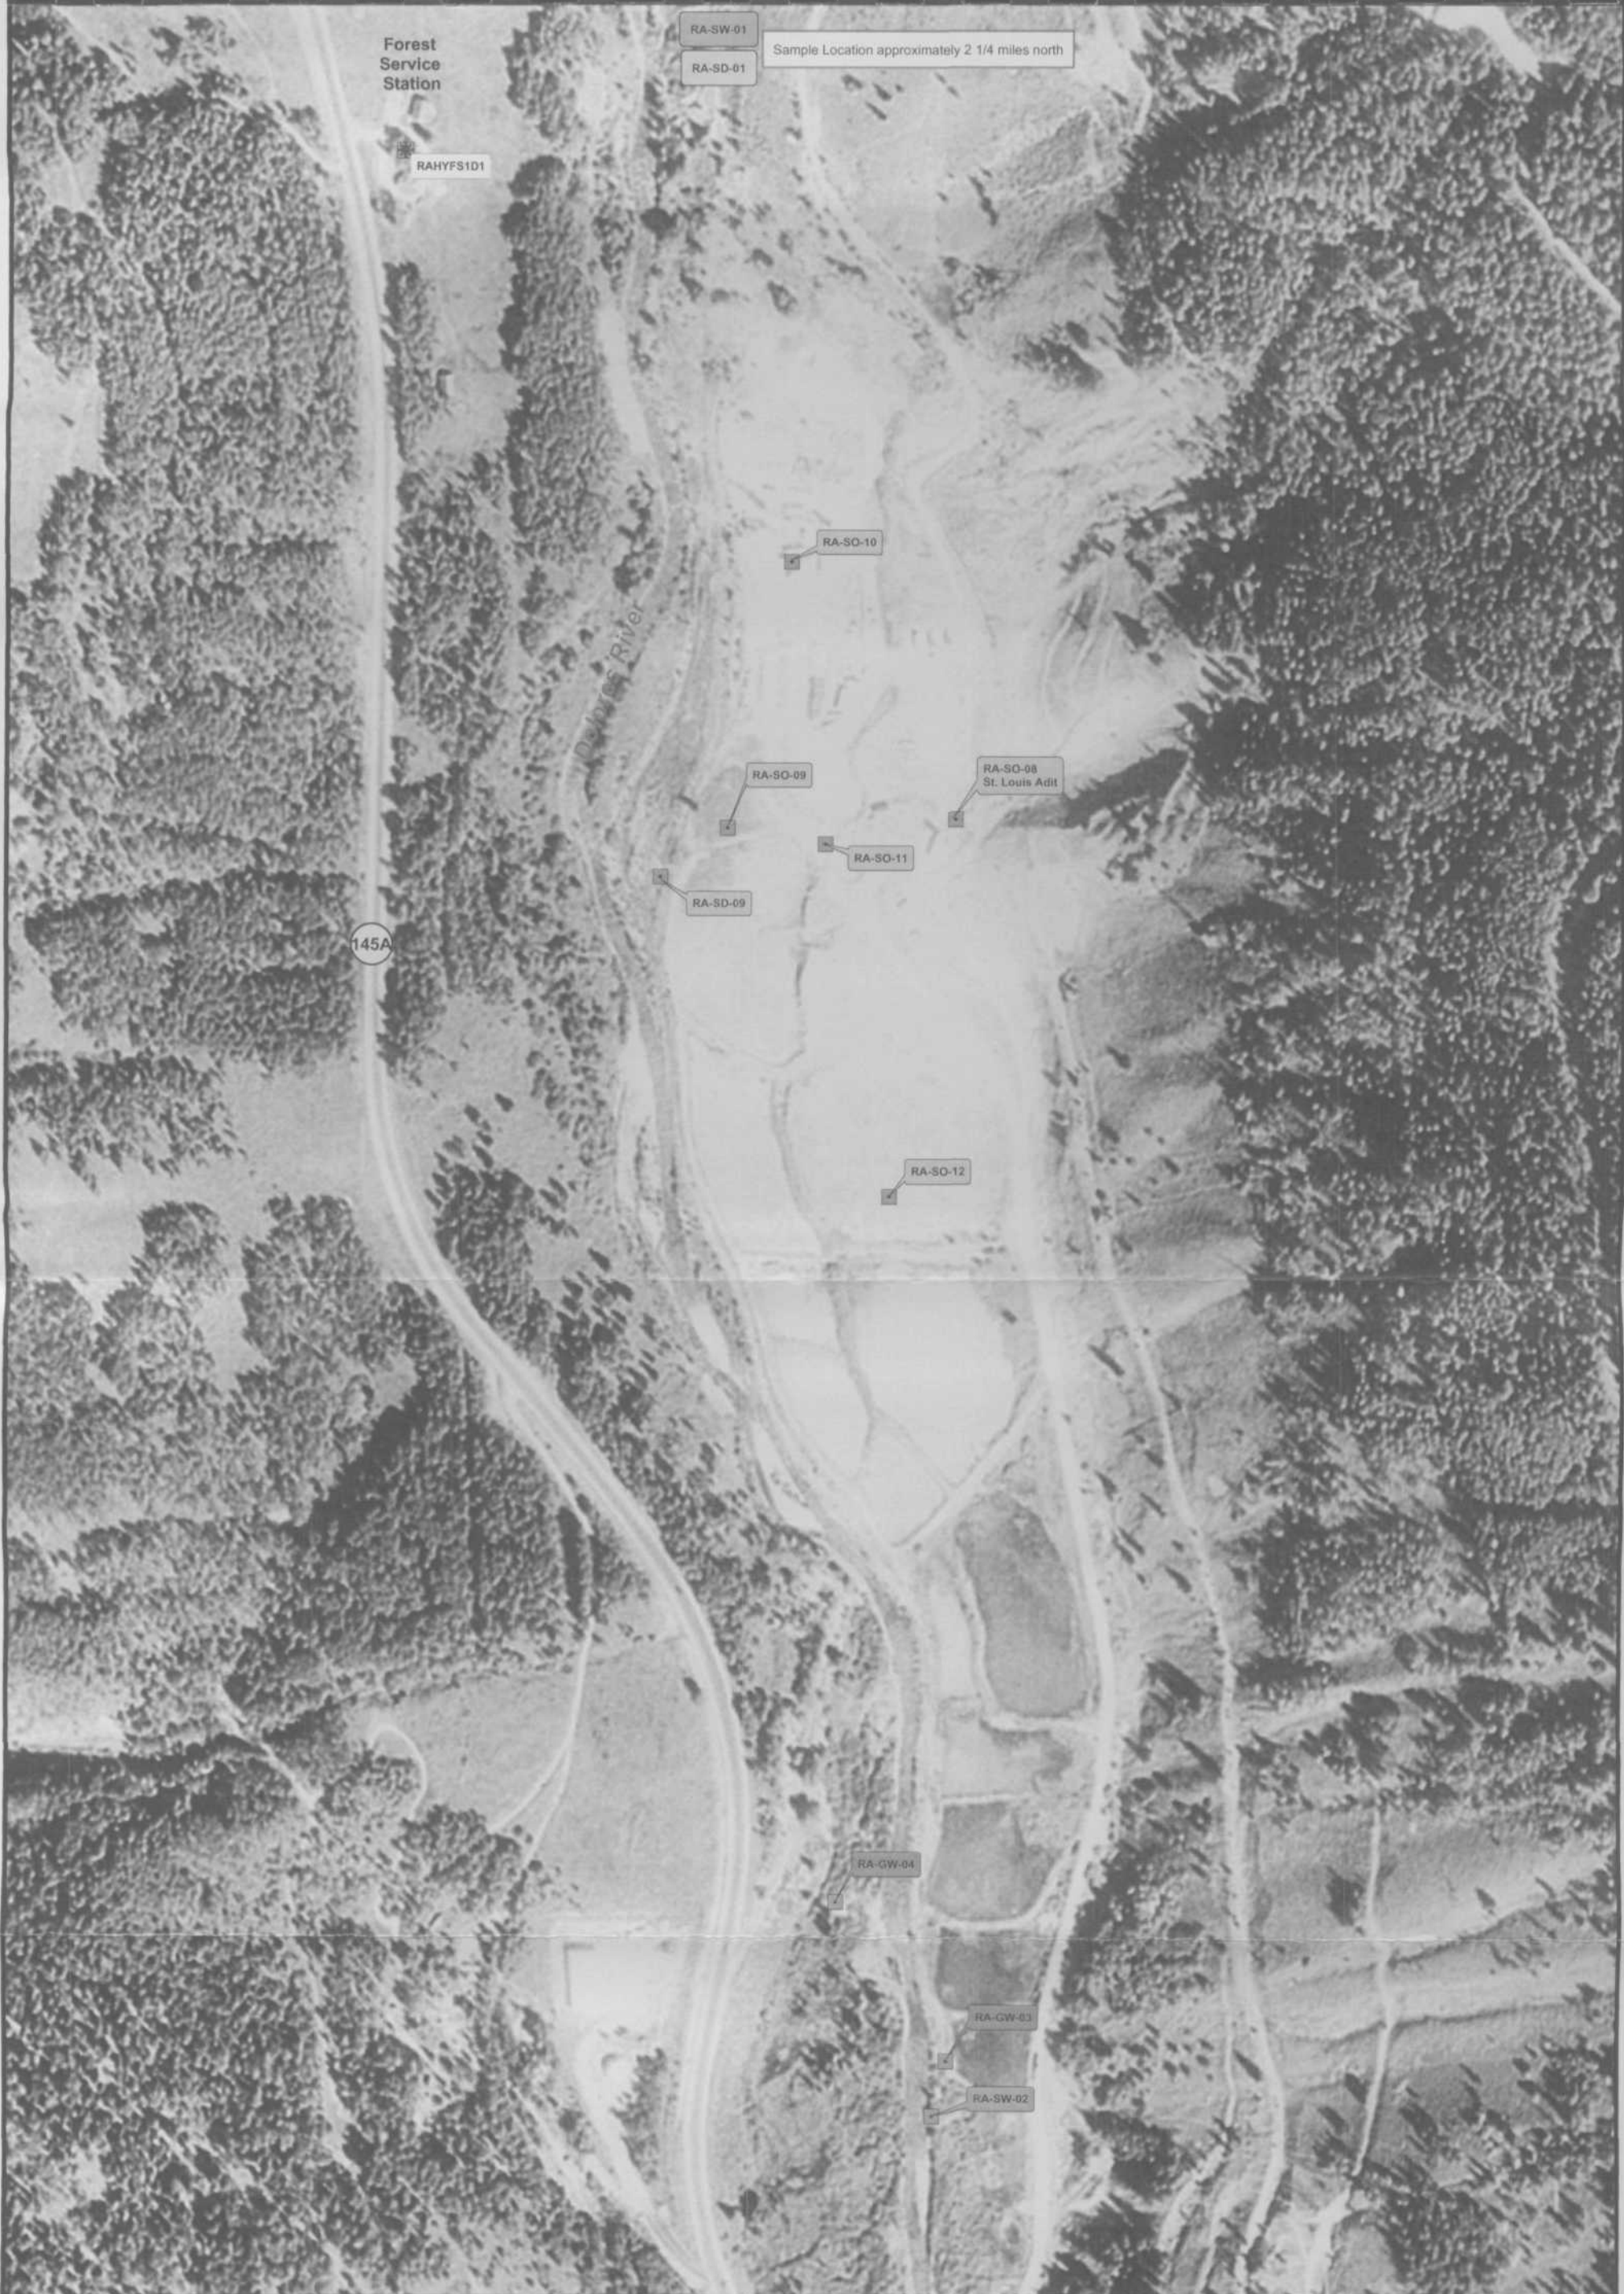
RA-SO-01	Source Sample Location and Sample ID
	RA-SW-08	Surface Water Sample Location and Sample ID
	RA-SO-01	Sediment Sample Location and Sample ID
	RA-GW-04	Groundwater Sample Location and Sample ID
	RAATP1D1	Residential Soil Background Sample with Laboratory Confirmation

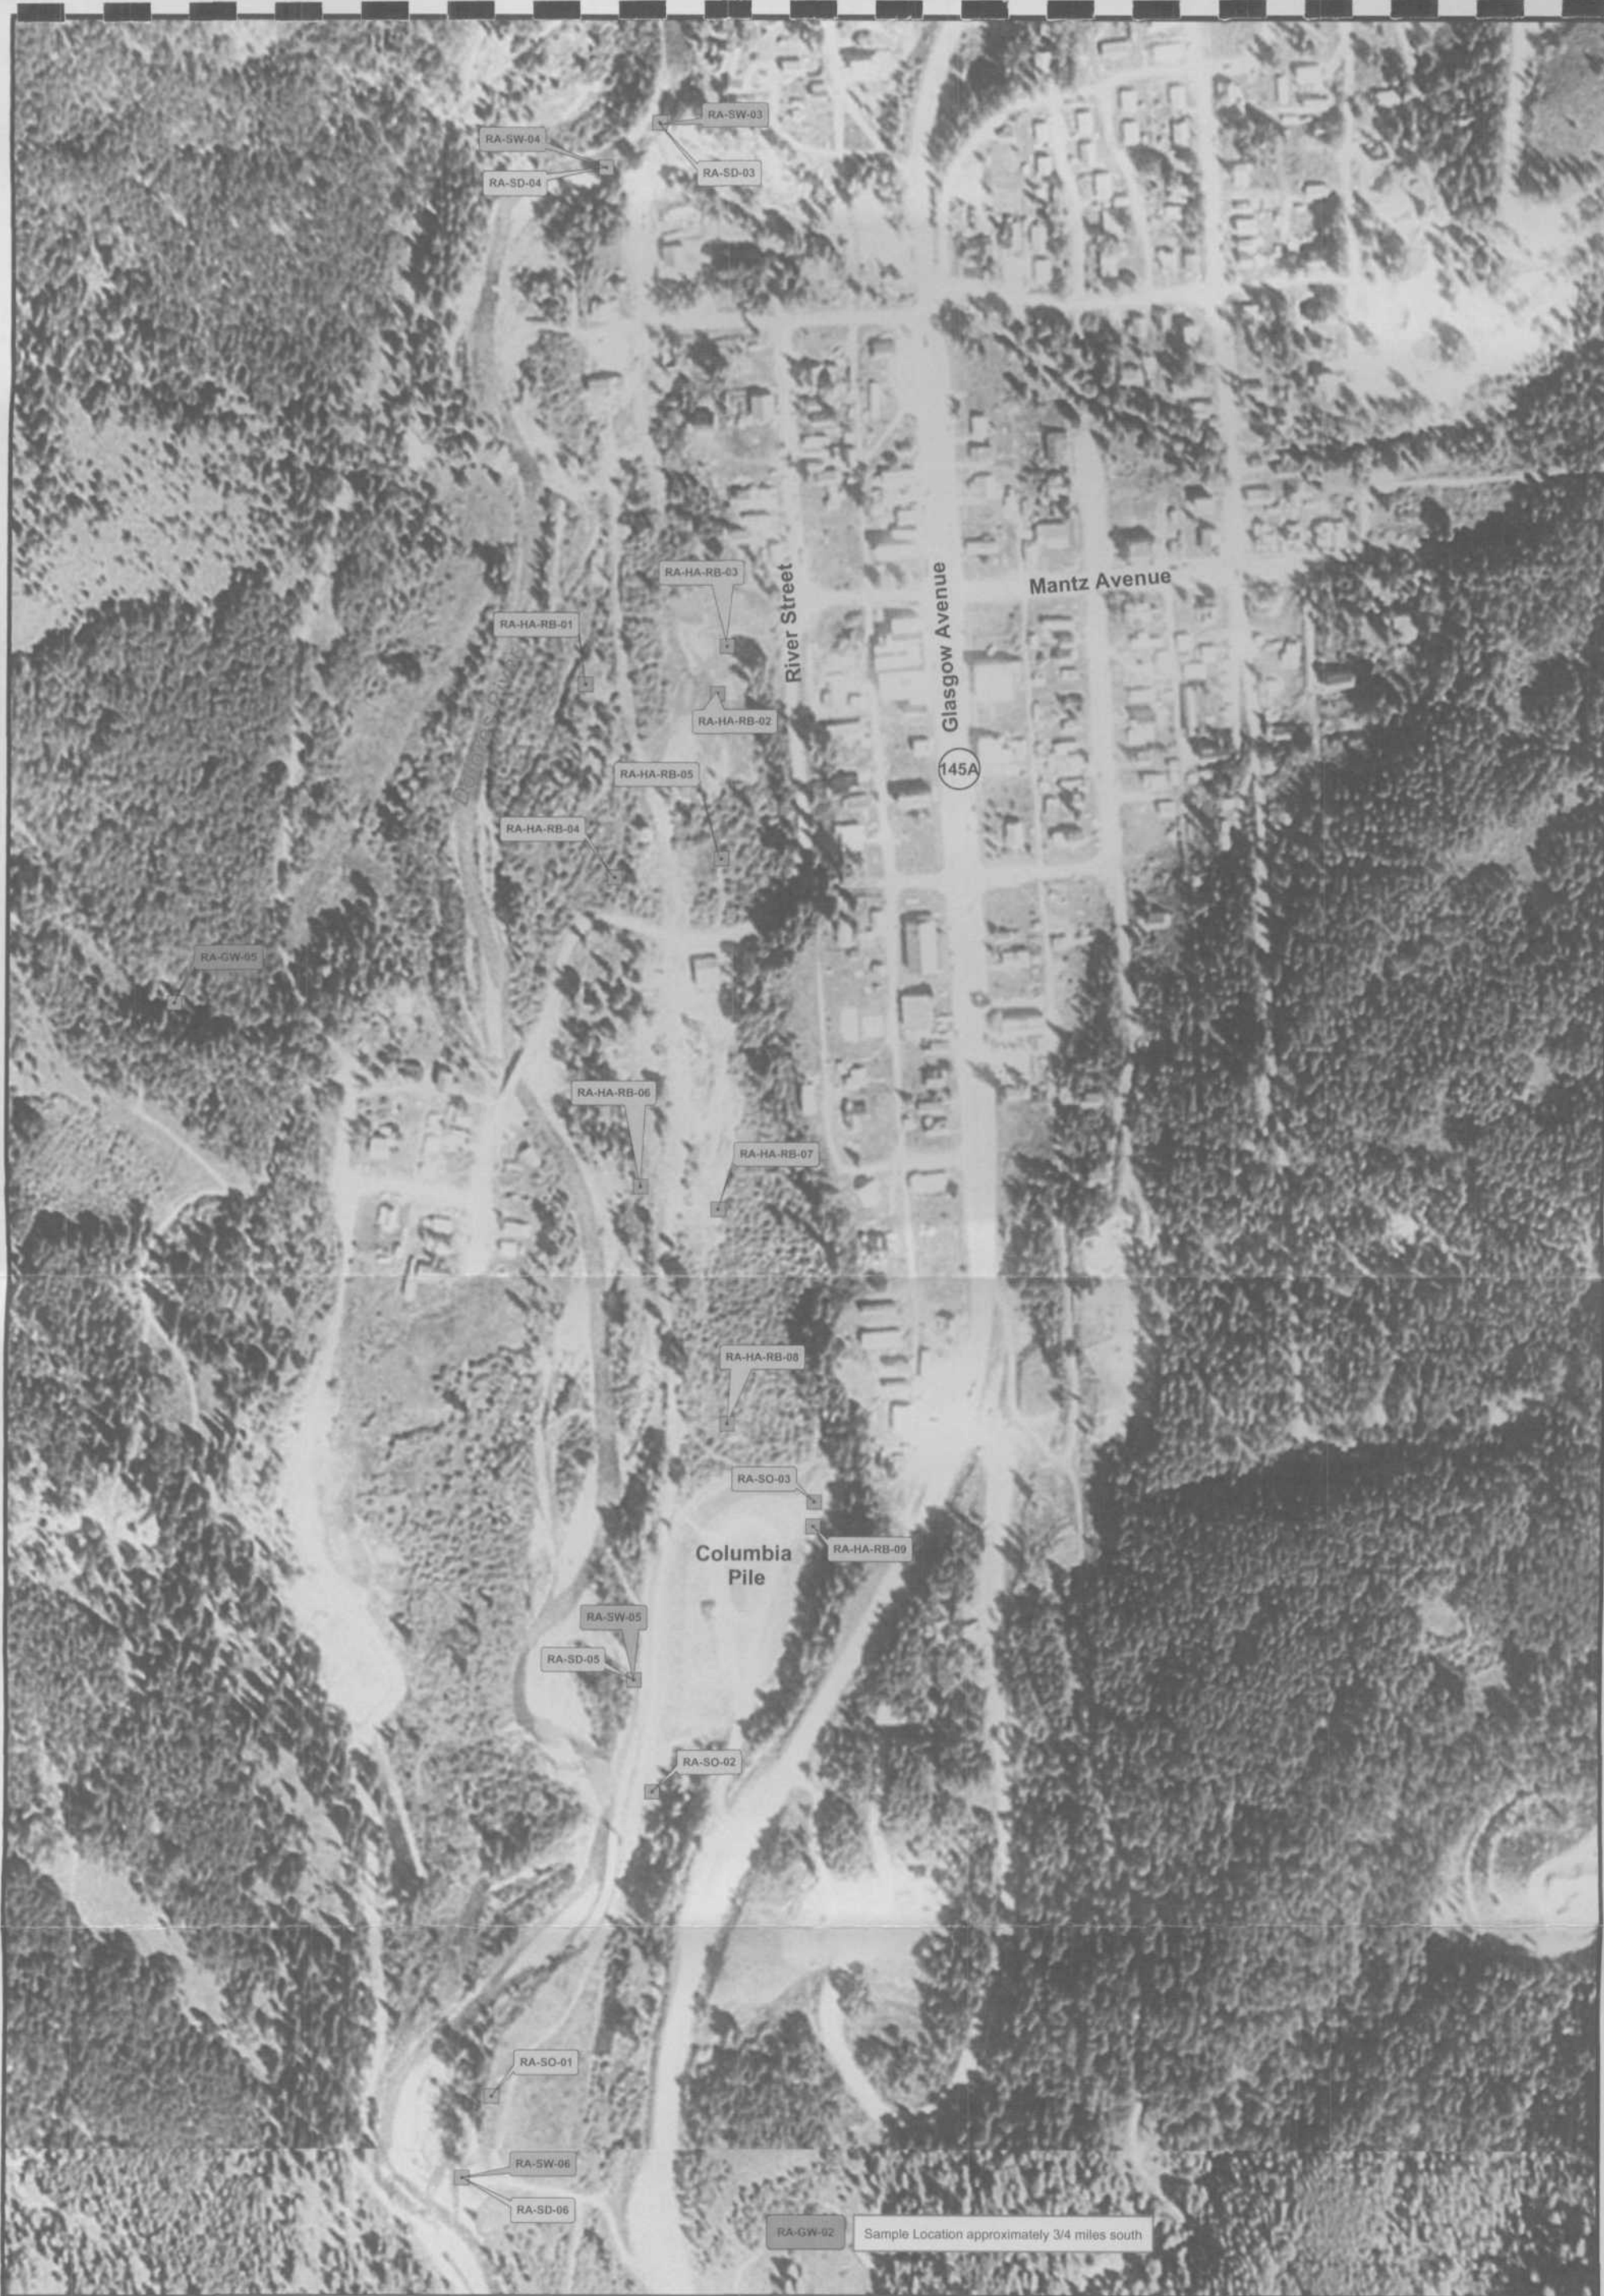
Rico Argentine
Rico, Dolores County, Colorado
Dolores River/Rico Sample Location Map
Figure 4

Sample RA-SO-01 was collected from a reclaimed area south of the Columbia pile along the Dolores River from a depth of less than 3 inches bgs (Figure 4). This area is generally well vegetated with established cover, although shallow erosional cuts were observed leading to the river. Analytical results for sample RA-SO-01 showed concentrations of the following analytes: 42 J parts per million (ppm) arsenic; 81 ppm cadmium; 16,000 ppm lead; 0.75 ppm mercury; 66 ppm silver; and 15,000 J ppm zinc (Table 4). A "J" qualifier indicates the quantity is estimated. Using a GPS, the area of the reclaimed site/waste pile was estimated to be approximately 2 acres (UOS 2003b).

Legend			
	RA-SO-01	Source Sample Location and Sample ID	
	RA-SW-08	Surface Water Sample Location and Sample ID	
	RA-SO-01	Sediment Sample Location and Sample ID	
	RA-GW-02	Groundwater Sample Location and Sample ID
